**TRAFFIC QUALITY ON THE ATLANTA
REGIONAL HIGHWAY SYSTEM**

(FALL 1998)

FINAL REPORT

*Prepared by
Skycomp Inc, Columbia, Maryland
for the Georgia Department of Transportation*

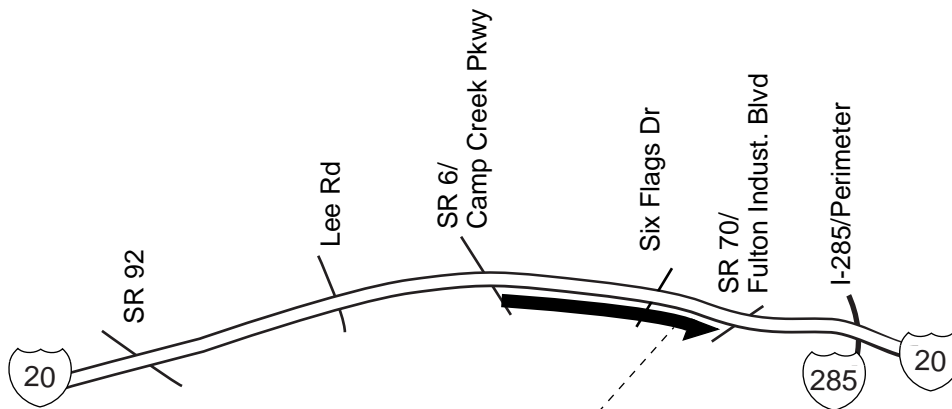
I-20 (WEST OF PERIMETER) MORNING (FALL 1998)

During most observations before 8:00 a.m., moderate to severe eastbound congestion was found on I-20 between Camp Creek Pkwy and Fulton Industrial Blvd. This congestion was exacerbated by two separate lane drops (4 lanes to 3) located between these interchanges; east of Fulton Ind. Blvd, traffic flow typically improved.

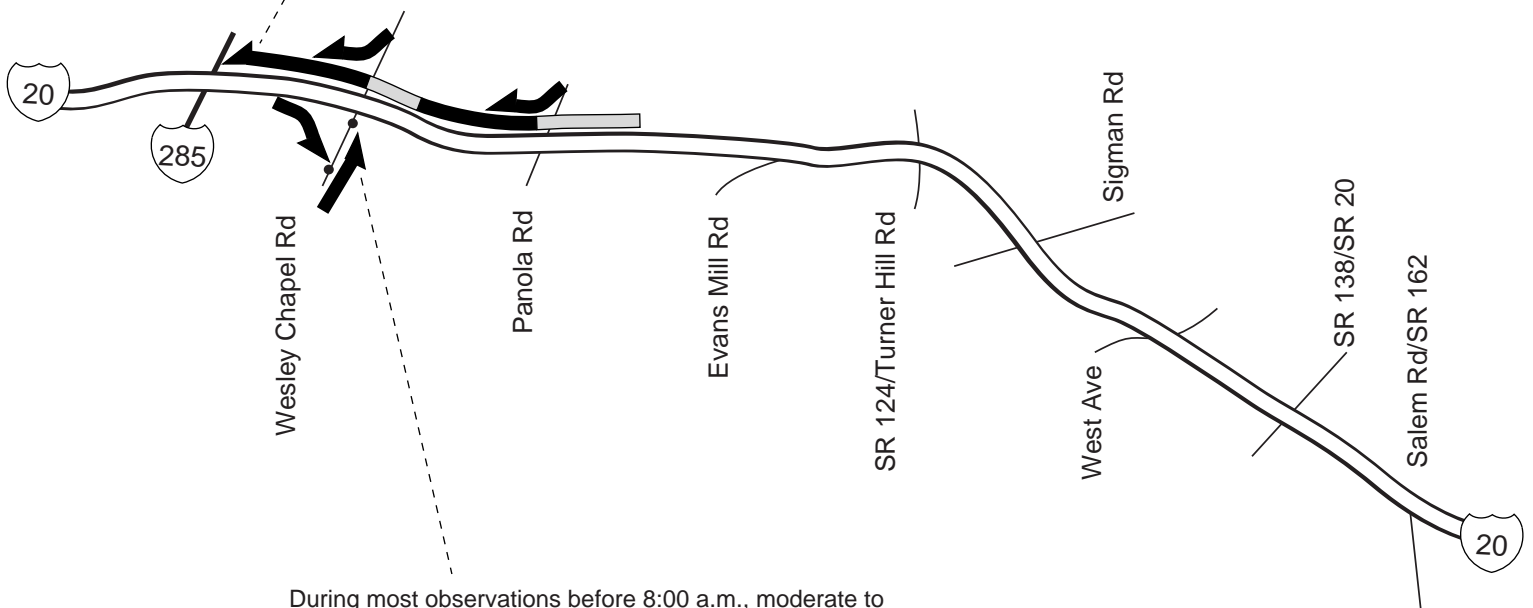
During most observations before 8:00 a.m., westbound congestion was found on I-20 between the vicinity of Panola Rd and the Perimeter; traffic entering at Panola Rd and Wesley Chapel Rd interchanges appeared to contribute to this congestion. Estimated average speed typically ranged from approximately 30-50 mph; some stop-and-go conditions were found within this queue. (See photos 23 - 27.JPG)

During most observations before 8:00 a.m., moderate to severe northbound congestion was found on Wesley Chapel Rd approaching the signalized intersection at I-20; in some cases, this queue backed through the upstream signal at Rainbow Dr. Intermittently, the eastbound exit ramp at Wesley Chapel Rd was congested; vehicles were queued at the signal at the head of the ramp. (See photo 28.JPG)

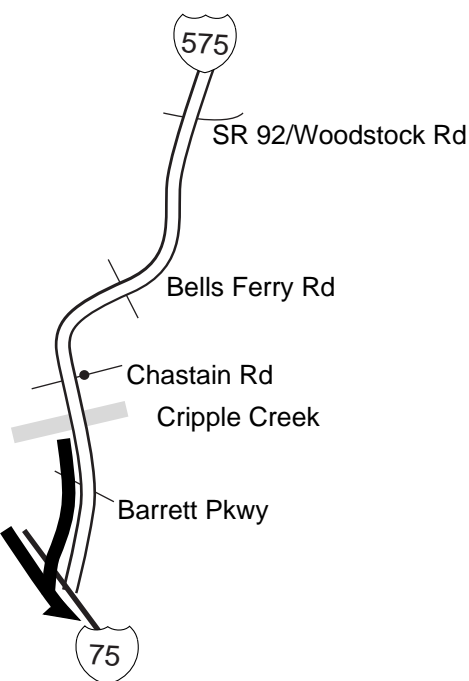
During all observations before 8:00 a.m., moderate to severe congestion was found on I-575 approaching the terminus at I-75; the tail of this queue typically extended back between Barrett Pkwy and Chastain Rd. Estimated average speeds within this queue was typically less than 20 mph. Traffic on the two lane ramp from I-575 typically had to merge into congested southbound flow on I-75. (See photos 152 - 155.JPG)

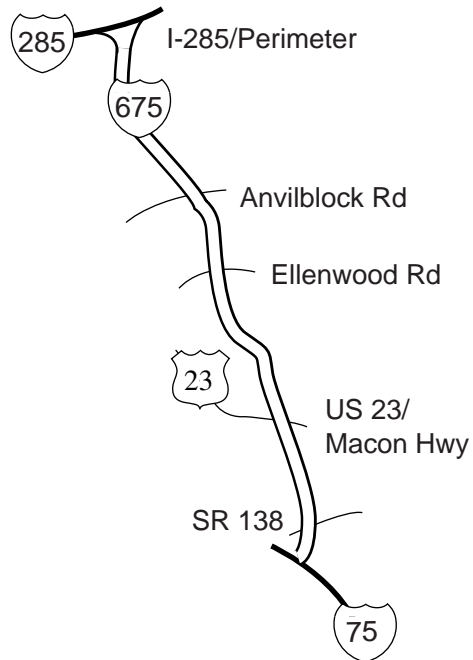
I-675
MORNING (FALL 1998)

No significant congestion was found on I-675 during the morning survey period.

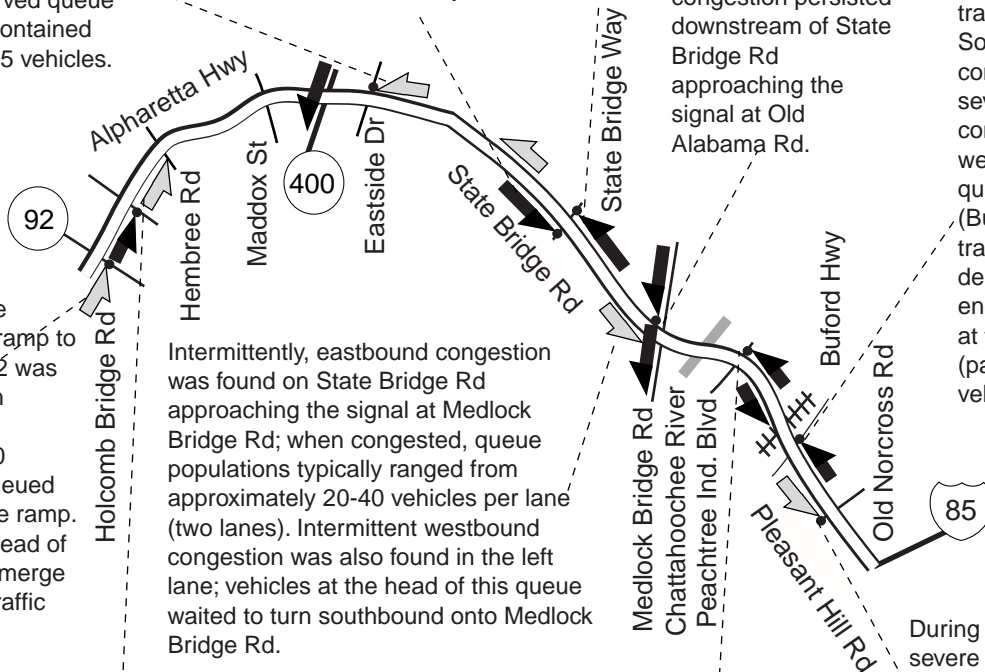
During most observations after 7:30 a.m., severe westbound congestion was found on State Bridge Rd approaching the signal at the merge with State Bridge / Kimball Way; in several cases, this queue extended all the way back to Jones Bridge Rd. This congestion was exacerbated by ongoing construction in this vicinity.

During most observations, severe southbound congestion was found on Medlock Bridge Rd approaching the signal at State Bridge Rd; in some cases, the queue extended back through several upstream signals. Severe southbound congestion persisted downstream of State Bridge Rd approaching the signal at Old Alabama Rd.

During most observations between 7:30 an 9:00 a.m., moderate to severe congestion was found in each direction on Pleasant Hill Rd approaching the signal at Buford Hwy. In addition to the signal, the intermittent blockage of the roadway at the train tracks (Norfolk Southern Railway) contributed to the severity of this congestion. Vehicles were intermittently queued at the signal (Buford Hwy) and the train tracks. Extensive delays were typically encountered by vehicles at this location (particularly northbound vehicles).

Intermittently, moderate to severe westbound congestion was found on State Bridge Rd approaching the signal at Eastside Dr; when congested, the left lane queue was extensive. The maximum observed queue in the left lane contained approximately 75 vehicles.

During most observations between 7:30 and 8:30 a.m., moderate to severe eastbound congestion was found on State Bridge Rd approaching the signals where the roadway divides at State Bridge / Kimball Way; this congestion was exacerbated by a lane drop (2 lanes to 1) and ongoing construction in this vicinity.

Intermittently, eastbound congestion was found on State Bridge Rd approaching the signal at Medlock Bridge Rd; when congested, queue populations typically ranged from approximately 20-40 vehicles per lane (two lanes). Intermittent westbound congestion was also found in the left lane; vehicles at the head of this queue waited to turn southbound onto Medlock Bridge Rd.

During most observations after 7:30 p.m., eastbound congestion was found on Alpharetta Hwy approaching the signal at Mansell Rd; queue populations typically ranged from approximately 20-40 vehicles per lane (two lanes).

Before 8:30 a.m., moderate to severe westbound congestion was found on Pleasant Hill Rd approaching the signal at Peachtree Industrial Blvd; in some cases, the queue extended back through the upstream signal at Howell Ferry Rd (a distance of approximately 1/2 mile).

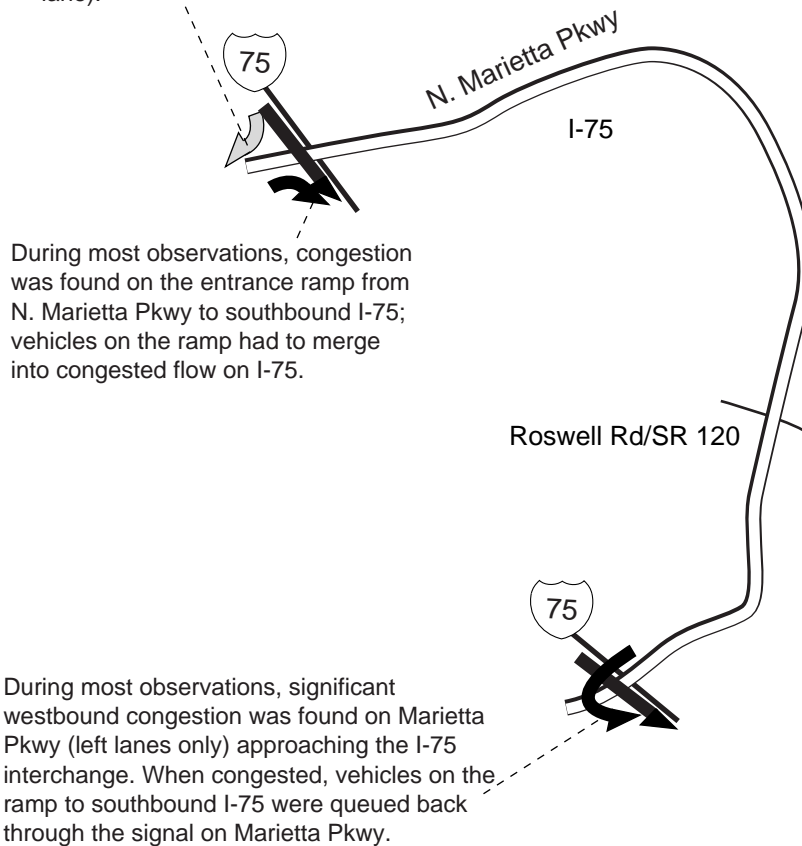
During most observations before 8:00 a.m., the southbound exit ramp at N. Marietta Pkwy was congested; single lane queue populations were estimated at approximately 20-25 vehicles (left lane).

During most observations, congestion was found on the entrance ramp from N. Marietta Pkwy to southbound I-75; vehicles on the ramp had to merge into congested flow on I-75.

During most observations, significant westbound congestion was found on Marietta Pkwy (left lanes only) approaching the I-75 interchange. When congested, vehicles on the ramp to southbound I-75 were queued back through the signal on Marietta Pkwy.

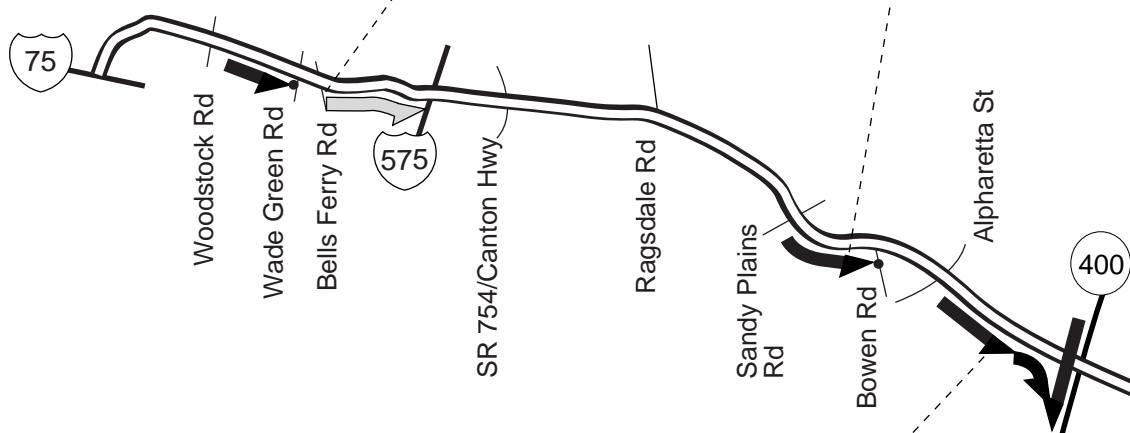
During most observations, moderate to severe eastbound congestion was found on SR 92 approaching the signal at Wade Green Rd; queue populations ranged widely between approximately 20 and 75 vehicles (one lane). East of Wade Green Rd, large platoons appeared to progress steadily up to where the roadway widens from 1 to 2 lanes (vicinity of the I-575 interchange). (See photos 258 - 260.JPG)

During most observations before 8:30 a.m., severe eastbound congestion was found on SR 92 approaching the signal at Bowen Rd; extensive queues (1-2 miles in length) often extended back to the vicinity of Sandy Plains Rd. (See photos 264 - 269.JPG)

During most observations before 9:00 a.m., severe eastbound congestion was found on SR 92 approaching the SR 400 interchange; extensive queues (1-2 miles in length) often extended back through several upstream signals. At times, the head of the queue was located downstream on the entrance ramp to southbound SR 400. (See 261 - 263.JPG)

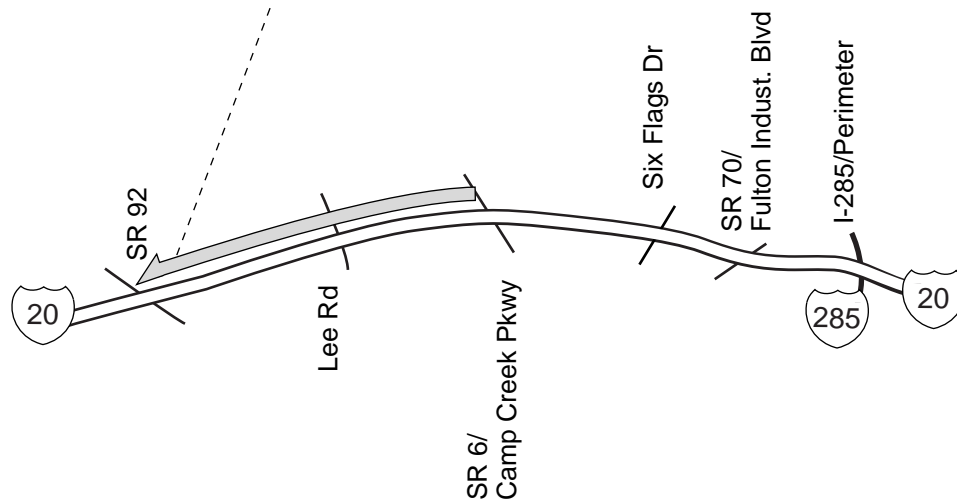
During most observations between 5:30 and 6:30 p.m., heavy westbound traffic flow was found on I-20 between Camp Creek Pkwy and SR 92 (estimated speeds approx. 50 mph). The lane drop (4 lanes to 3) west of Camp Creek Pkwy contributed to this slowing.

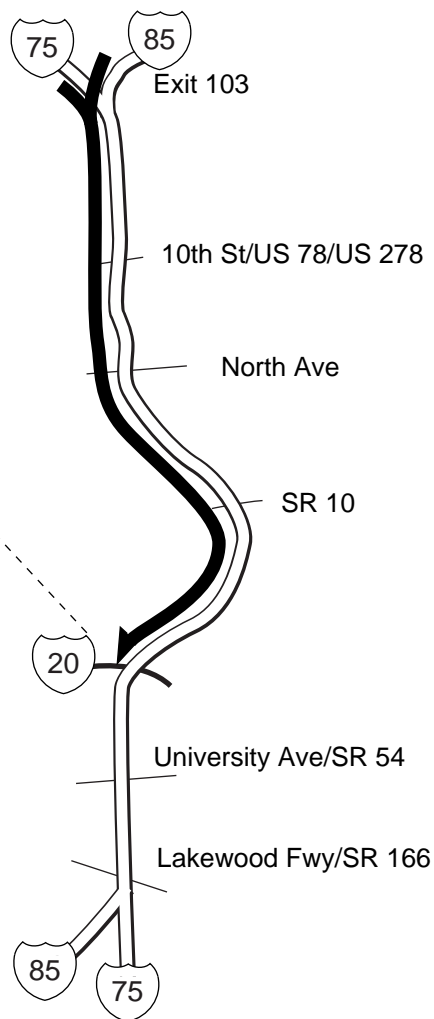
During all observations, moderate to severe southbound congestion was found on I-75/85 between the merge at exit 103 and downtown. Merging and weaving at the series of closely spaced interchange ramps appeared to exacerbate this congestion. Estimated speeds along I-75/85 typically averaged less than 25 mph (intermittent stop-and-go conditions were found during the peak hour). South of I-20, traffic typically improved.
